OPERATING EXPERIENCE WEEKLY SUMMARY

Office of Nuclear and Facility Safety

May 21 - May 27, 1999

Summary 99-21

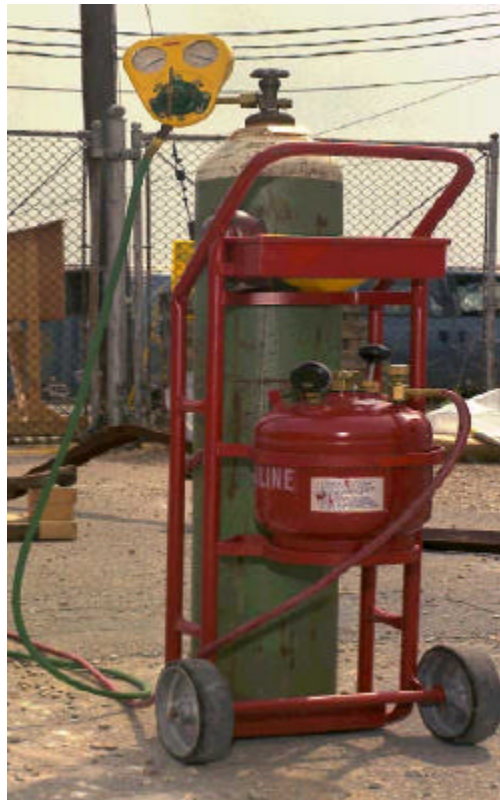
Figure 4-1. Oxy-Gasoline Cutting System

On May 19, 1999, at the Hanford Site Inactive Facilities Surveillance and Maintenance Facility, a flashback occurred in the oxygen line for an oxy-gasoline cutting system when a decommissioning and decontamination (D&D) worker ignited the torch. The flashback ruptured and separated the oxygen hose at a point approximately 10 ft from the D&D worker and 50 ft from the gasoline tank. The worker was cutting on the north side of a 6-ft diameter, 5/8-in. steel pipe, and the rupture occurred on the south side of the pipe. A D&D worker who was on the south side of the pipe heard a loud crack and observed a road-flare-sized flame at the rupture. He quickly shut off the oxygen supply. No other personnel were within 10 ft of the burst, and no personnel were injured; however, a rupture closer to the D&D worker using the torch could have caused burns or other injury. (ORPS Report RL--BHI-IFSM-1999-0004)

The oxy-gasoline cutting system (Figure 4-1) consists of a standard oxygen cylinder, a pressurized 3-gal tank of unleaded gasoline, hoses, and a cutting torch. The tank delivers gasoline to the torch in liquid form, where it vaporizes and mixes with oxygen at the torch tip. Flashbacks on the fuel side are not possible because of the liquid state in the line. Also, a quick-close, high-flow valve at the gasoline tank immediately shuts off fuel if a line ruptures. The oxy-gasoline system offers several advantages over the standard oxy-acetylene cutting system, including safety, economy in fuel and labor-hours, longer tip life, faster burning, and little or no slag production.

The D&D workers immediately stopped work and notified their job supervisor. Investigators consulted the manufacturer's technical manual. The manual recognizes that backflow of fuel into the oxygen line is possible under some circumstances. It recommends purging the oxygen line before igniting the torch and installing an additional flashback arrestor in the oxygen line at the torch. A field engineer received the same recommendations orally from a representative of the manufacturer, who also said that an incomplete purge of the oxygen line could cause a flashback. The system in use already had a flashback arrestor at the oxygen cylinder, as required by the manufacturer. Facility personnel installed a flashback arrestor on the torch and tested the system successfully. Additional corrective actions include incorporating the additional flashback arrestor into training and preparing a lessons learned bulletin for distribution to potentially affected sites.

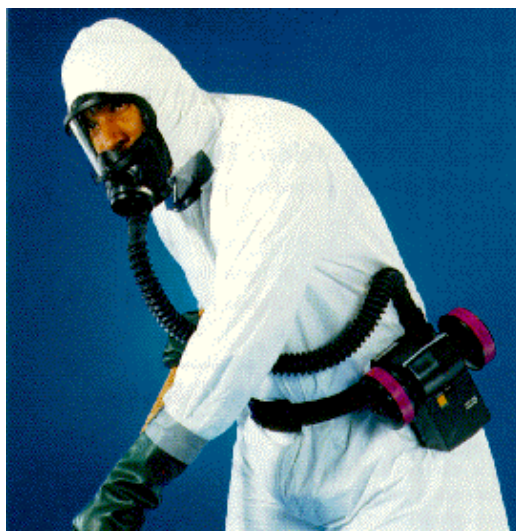
**Figure 5-1. MSA OptimAir 6A PAPR
(Courtesy Mine Safety Appliances Company)**

On March 30, 1999, at the Rocky Flats Site Environmental Technology Site, ten new Mine Safety Appliances (MSA) OptimAir 6A powered air purifying respirators (PAPR) with belt-mounted blowers malfunctioned during maintenance work. The malfunctions were excessive vibration, variable fan speeds, excessive noise, and, in two cases, complete shutdown. Malfunctions of PAPR blower motors can result in decreased respirator protection factors and can increase the risk of exposing the wearer to hazardous breathing air. (DOE Lessons Listserver Identifier KH-99-057.CA)

The site respiratory protection program administrator (RPPA) conducted a random evaluation of 37 new OptimAir 6A PAPR blowers and discovered that approximately 40 percent of the blowers evaluated had excessive vibration and/or varied flow rates. Rocky Flats personnel sent 21 malfunctioning OptimAir 6A blower modules to MSA for evaluation. MSA evaluated five of the modules. On April 22, 1999, MSA wrote a letter to the site RPPA stating that "the low flow and noise was caused by a loose impeller and that the impeller in each unit had loosened from the motor shaft causing the low flow." In addition, MSA stated that 18 of the 21 blower modules returned to MSA had been manufactured in March 1998.

MSA determined that the impellers were loose because of "improper adhesives used in the assembly of the impeller to the motor shaft during that time." Figure 5-1 shows a worker wearing an MSA OptimAir 6A PAPR.

MSA indicated that the defective units will be replaced under warranty, but they did not believe that a safety notice to users was warranted. Rocky Flats managers are currently evaluating options with the remaining units they have on site. Site personnel continue to use MSA OptimAir mask-mounted PAPRs.

Facility managers and personnel in charge of respiratory protection programs should check their inventories for these respirators and verify their correct operation. Personnel who wear respirators should ensure that they understand and implement the correct methods of wearing, operating, and checking their respirators. DOE/EH-0256T, *Radiological Control Manual*, 29 CFR 1910.134, *Respiratory Protection*, and ANSI Z88.2-1992, *Respiratory Protection*, discuss equipment and requirements of respiratory protection programs and provide additional references.
